RESERVOIR DESIGN - 'Look, Listen and Feel'

Future Reservoir Design

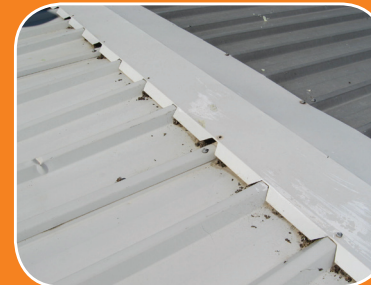
Ridge capping appears to be sealed.

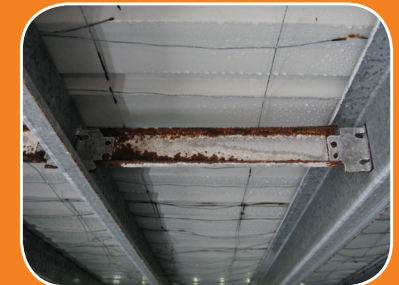
1. **Roof material failures** – metal products such as lower quality roofing screws, zincalume type rolled purlins and 'safety mesh' placed under steel roof sheets are showing serious failures in under 10 years. Most reputable manufacturers have provided good information of product suitability, yet this appears to have been ignored in many cases.

Corroded purlins and safety mesh.

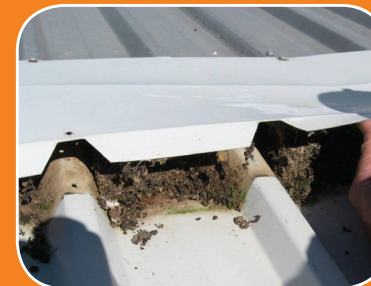
3. **The older 'centre pitched' roofing designs** are more expensive to construct and the numerous ridge flashings allow contaminants to accumulate and enter the tank. A roof utilizing full length sheets, combined with a lower pitch angle is better sealed and will allow maintenance tasks to be carried out in a safer manner.

Ridge capping debris.

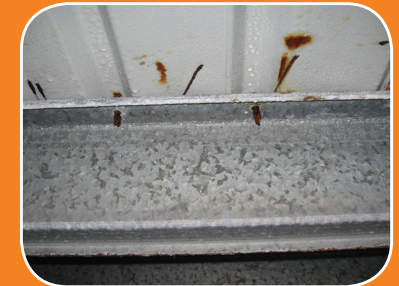
Corroded roof screws and safety mesh.

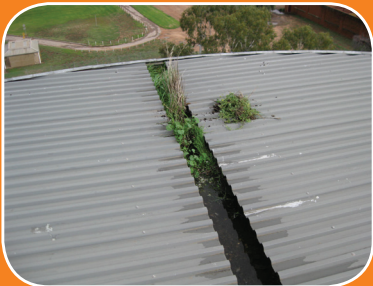
2. **Roof drainage systems** incorporating centre box gutters have a proven failure rate due to collapse and leakage issues, but they are now returning due to 'cut and paste' designing from older projects.

Box gutter blocked and overflowing.

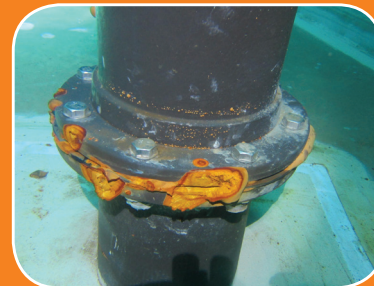
4. **Internal pipe work** that corrodes prematurely due to poor material selection or configurations that disturb sediments or make tank cleaning difficult.

New ductile iron pipework corroding.

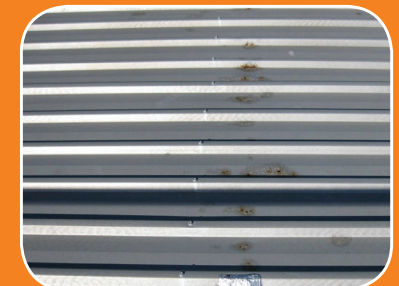
Roof sheet corrosion from safety mesh below.

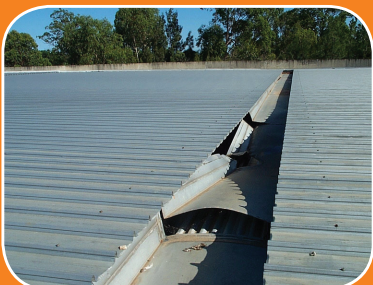
Box gutter collapsed.

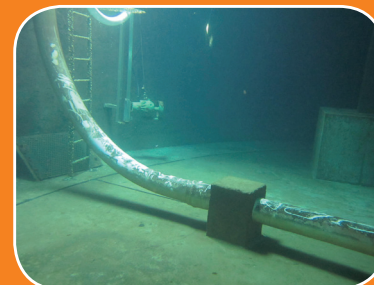
Pipe work should be under the floor.
