Waterwise Abseiling

Canberra Sediment Boom Removal

Glossodia Reservoir Repair

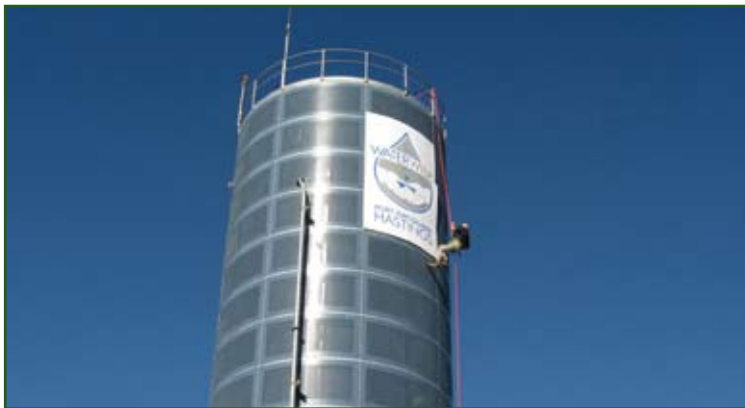
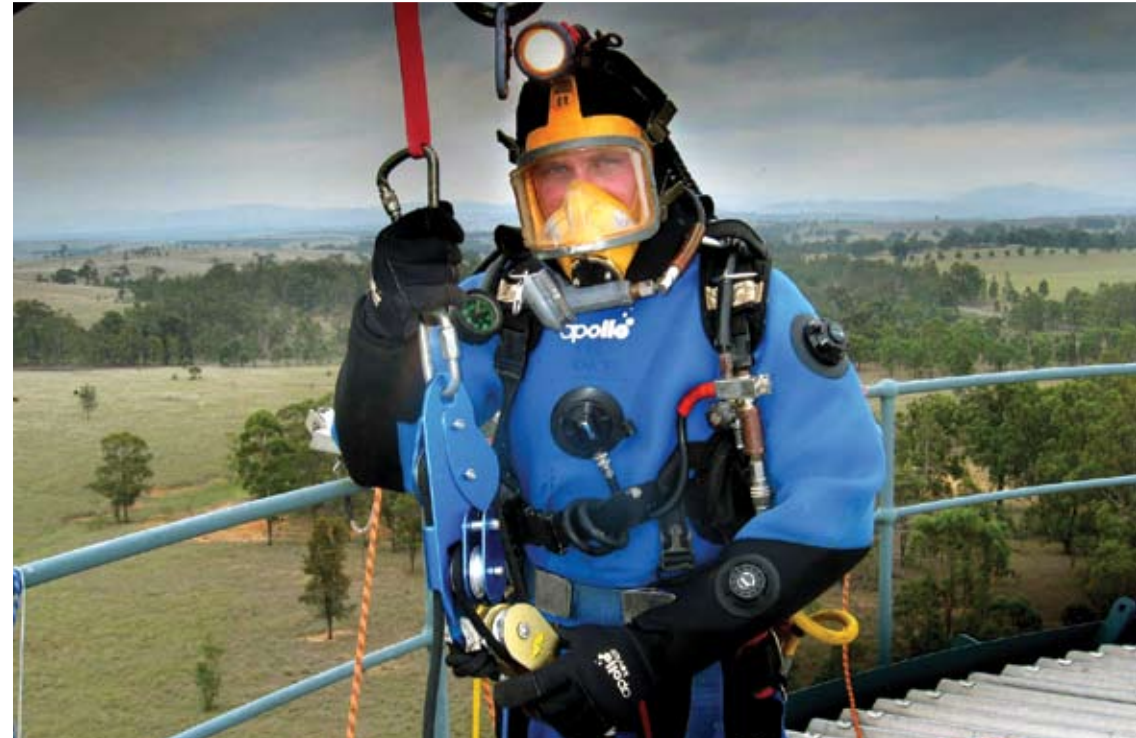
The 'waterwise' sign attached to a lime silo at Wauchope WTP had come loose on one corner, and the options for re-attaching it were limited - a large crane and man basket ...or some divers who were 'working close by'.

The Waterwise sign was a good opportunity to change over from diving to abseiling for an hour or so. The silo roof area offered good solid anchor points for the ropes and an operator was quickly 'over the side' and assessing the problem - a threaded stud that had worked loose and fallen out. A new stud was made up and then screwed in to securely attach the sign again - the remaining studs were also re-tightened at the same time to avoid any future failure from occurring.

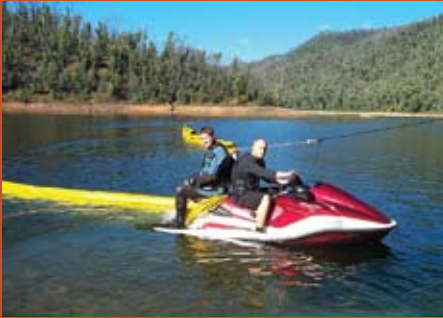
The boom material was breaking down and posing a threat to down stream pumps and pipe work.

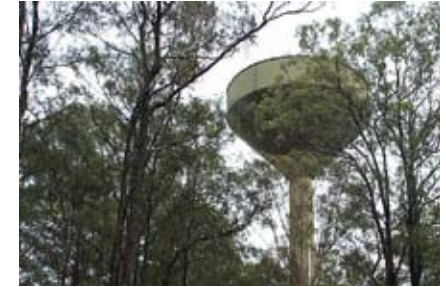
A 'wine glass' shaped reservoir thirty metres above the ground was displaying seepage through the centre access tunnel. This tank could not be removed from service, so any repairs had to be carried out while the tank remained full of water.

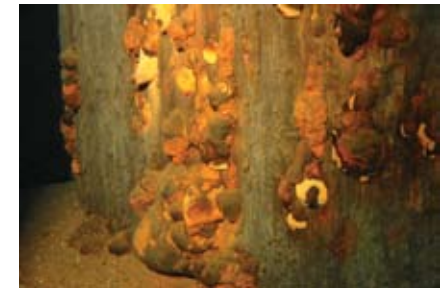
Internal inspection using a potable dedicated dive team revealed heavy localized corrosion to the tunnel wall area, adjacent to a brass protective screen covering the outlet penetration. The brass material was providing a strong cathodic reaction to the 8mm thick mild steel plating that comprised the access tunnel. After scraping back the bitumen protective coating and the corrosion nodules, a strong leak developed due to seven metres of water head pressure bearing on the affected area. A large adjacent area of tunnel wall was also identified as having less than 20 percent remaining of it's original plate thickness. A ten-cent coin was used to initially block the water flow. This was further sealed and held in place with 'Blue-Tac', which had sufficient viscosity to withstand the significant water pressure.
