Carbonation and Chlorides Testing – a client's approach to Condition Assessment Techniques

David Barry, AquaSafeSkills

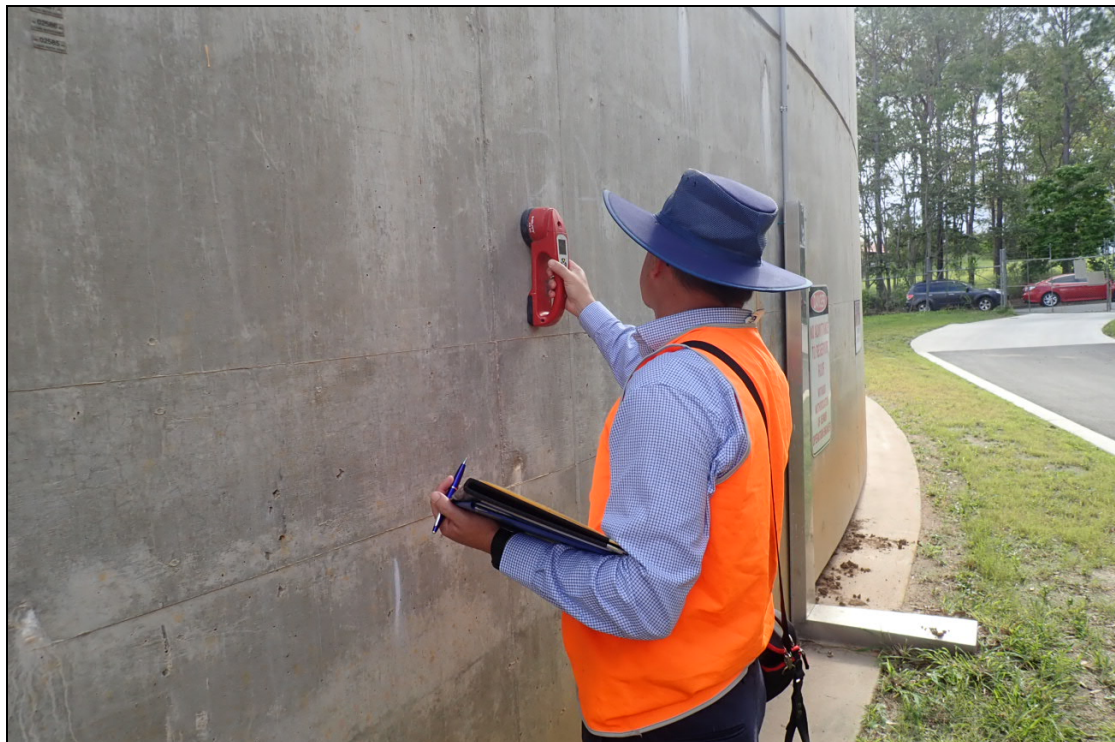
Figure 1: using a re-bar meter to conduct a steel cover depth assessment

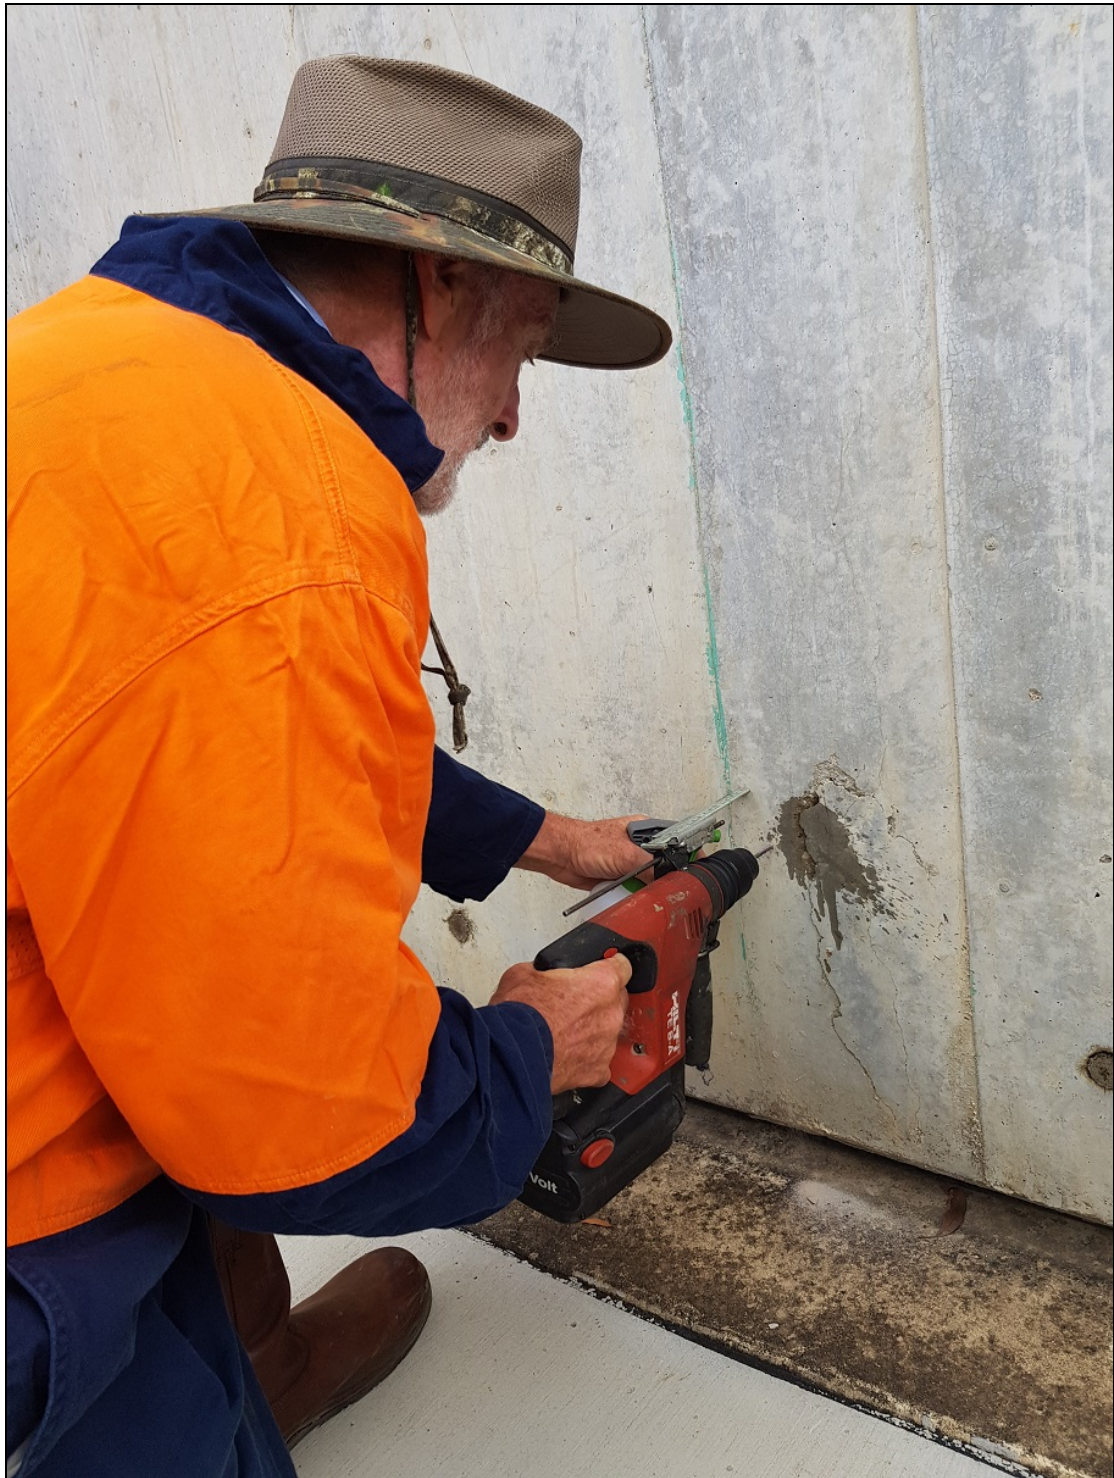
Figure 2: drilling holes in order to conduct carbonation deterioration depth

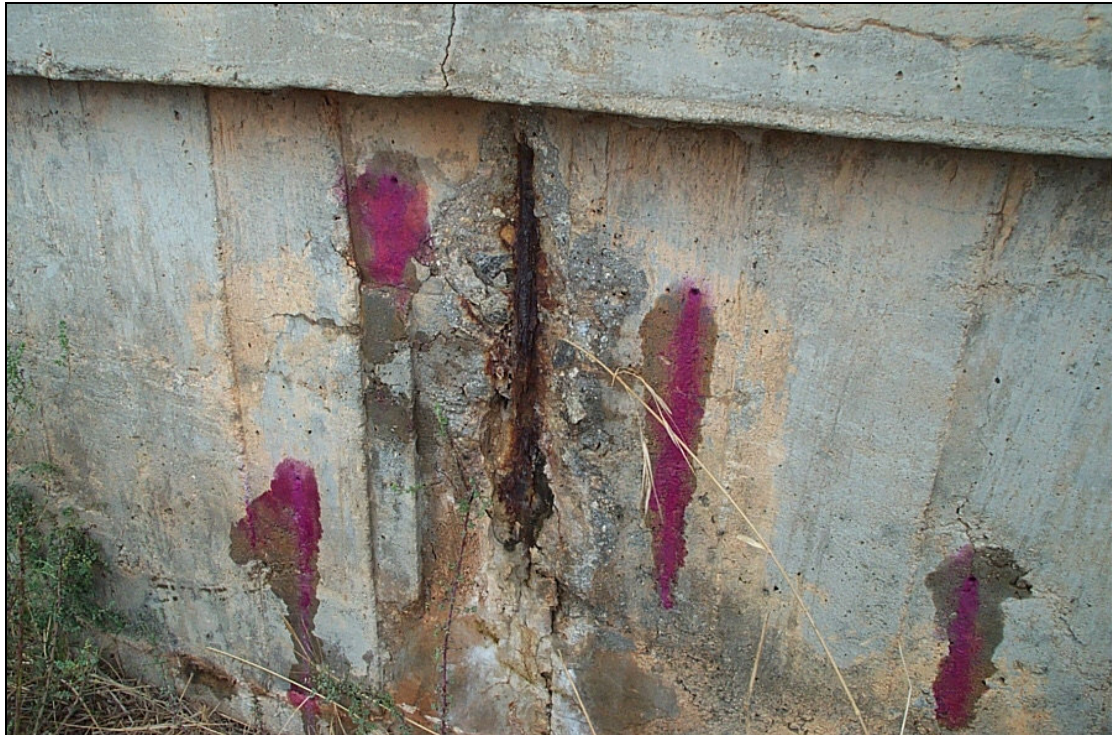
Figure 3 - purple tailings indicating that alkaline concrete has been detected

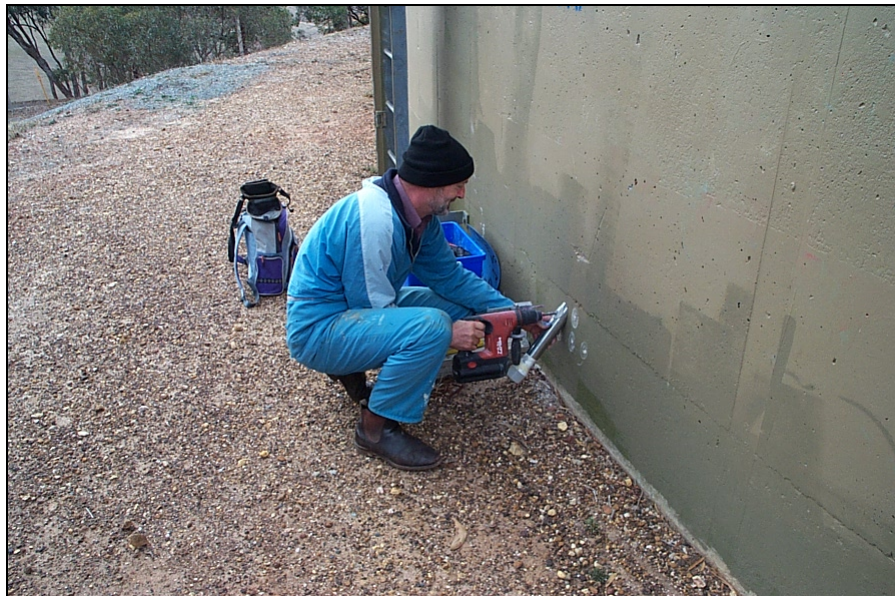
Figure 4: collecting a concrete dust sample for chlorides analysis
