Waterwise Abseiling

Canberra Sediment Boom Removal

Glossodia Reservoir Repair

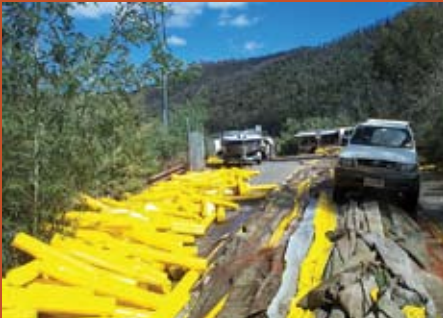
The booms were scattered along all the tributaries and inlets into the dams, often in shallow water and up to five kilometres from the base camp areas. In addition to our normal work boats, two Honda jet skis were used to support the divers and to 'power' a purpose built diving and harvesting barge. The jet skis could operate more safely in shallower waters than the boats and there were no entanglement issues with propellers, divers and airlines to worry about.

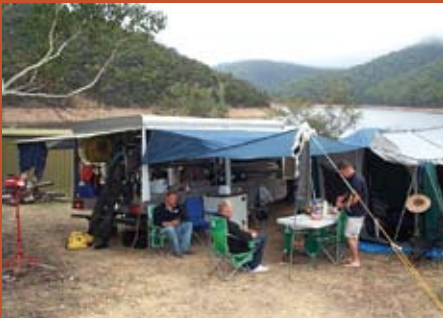
The project was further complicated by the absence of local motels and food supplies – Aqualift set up a complete two week onsite camp. Tents, swags, nutritious food and a mobile office including satellite phones were simply 'part of the job'.
