# Reservoir Awareness and Responsibilities

Jillian Busch and Dave Barry  
Aqualift Project Delivery Pty Ltd  
2014

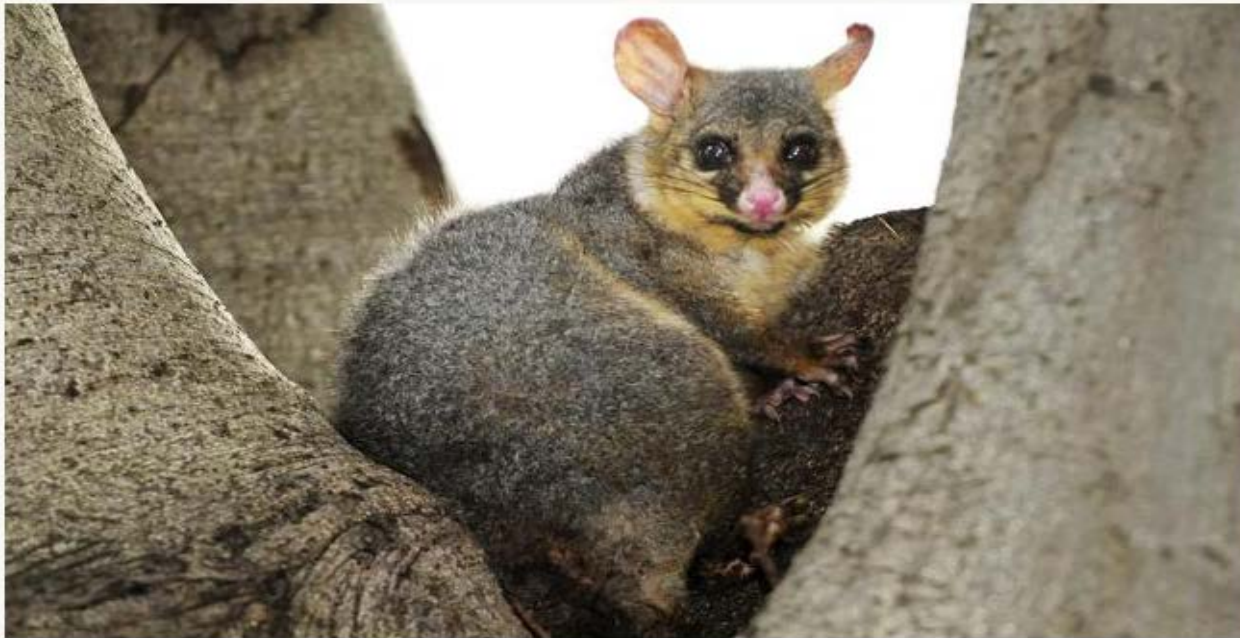
A dead possum has contaminated the water supply of [redacted] Source: News Limited

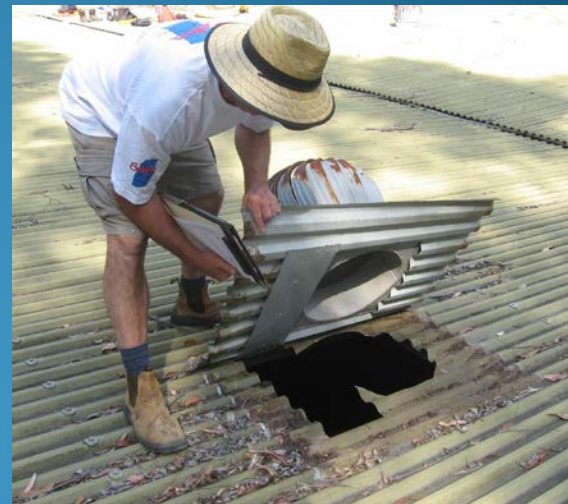
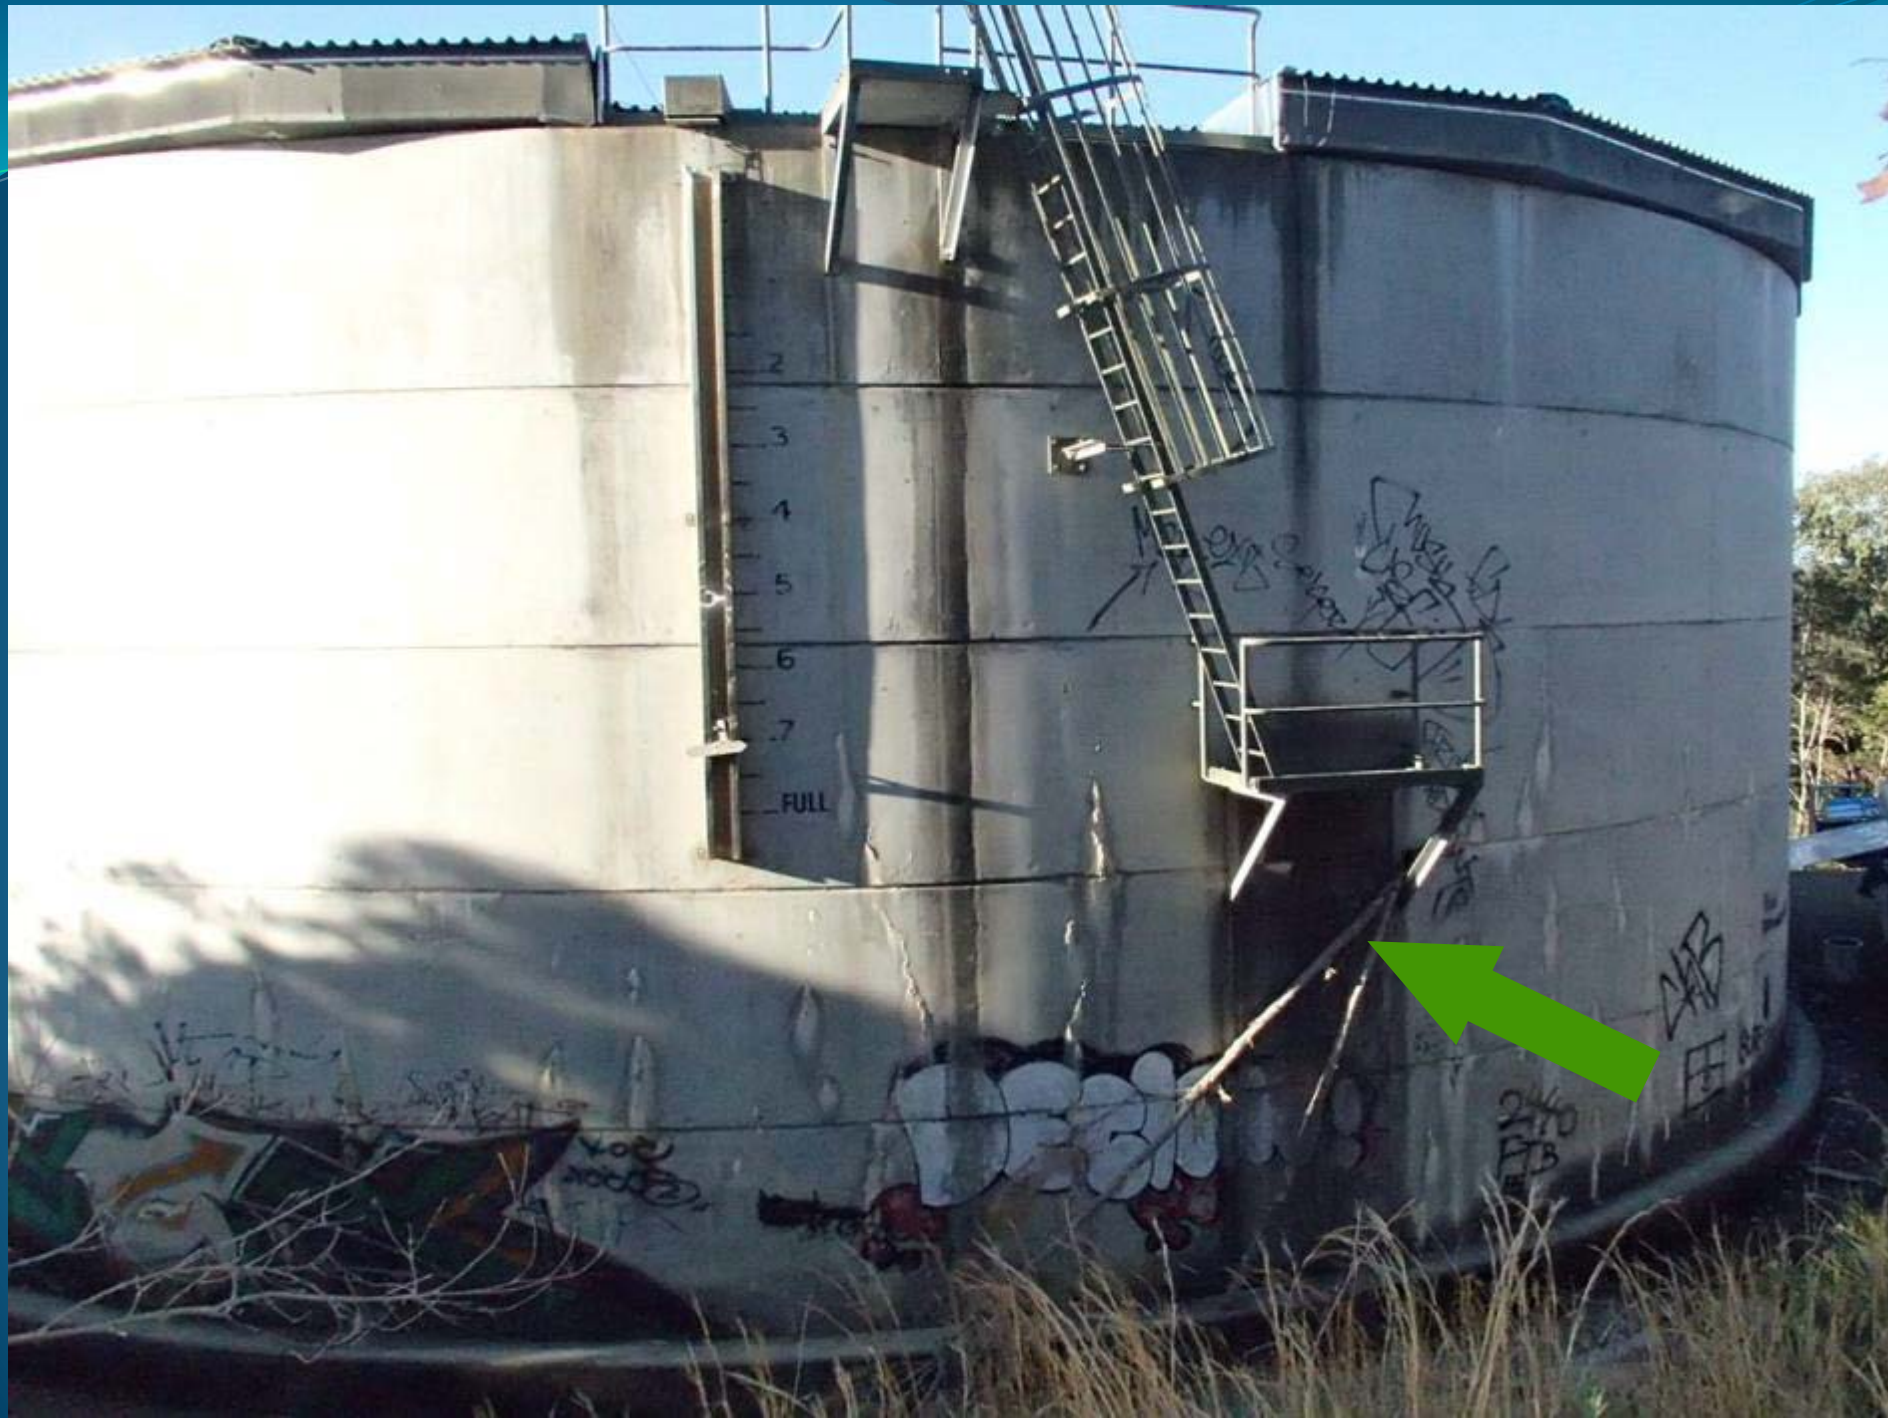
- The 'usual' contamination points
- Entry hatch & platform
- Roof area
- Evidence within the tank
- Under the water line

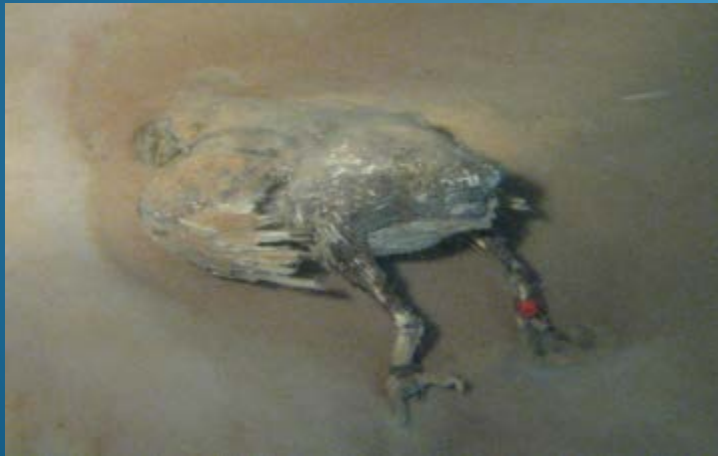
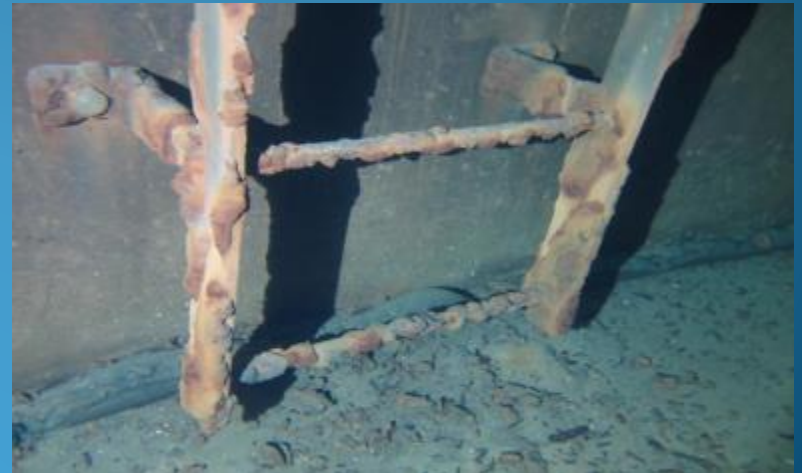
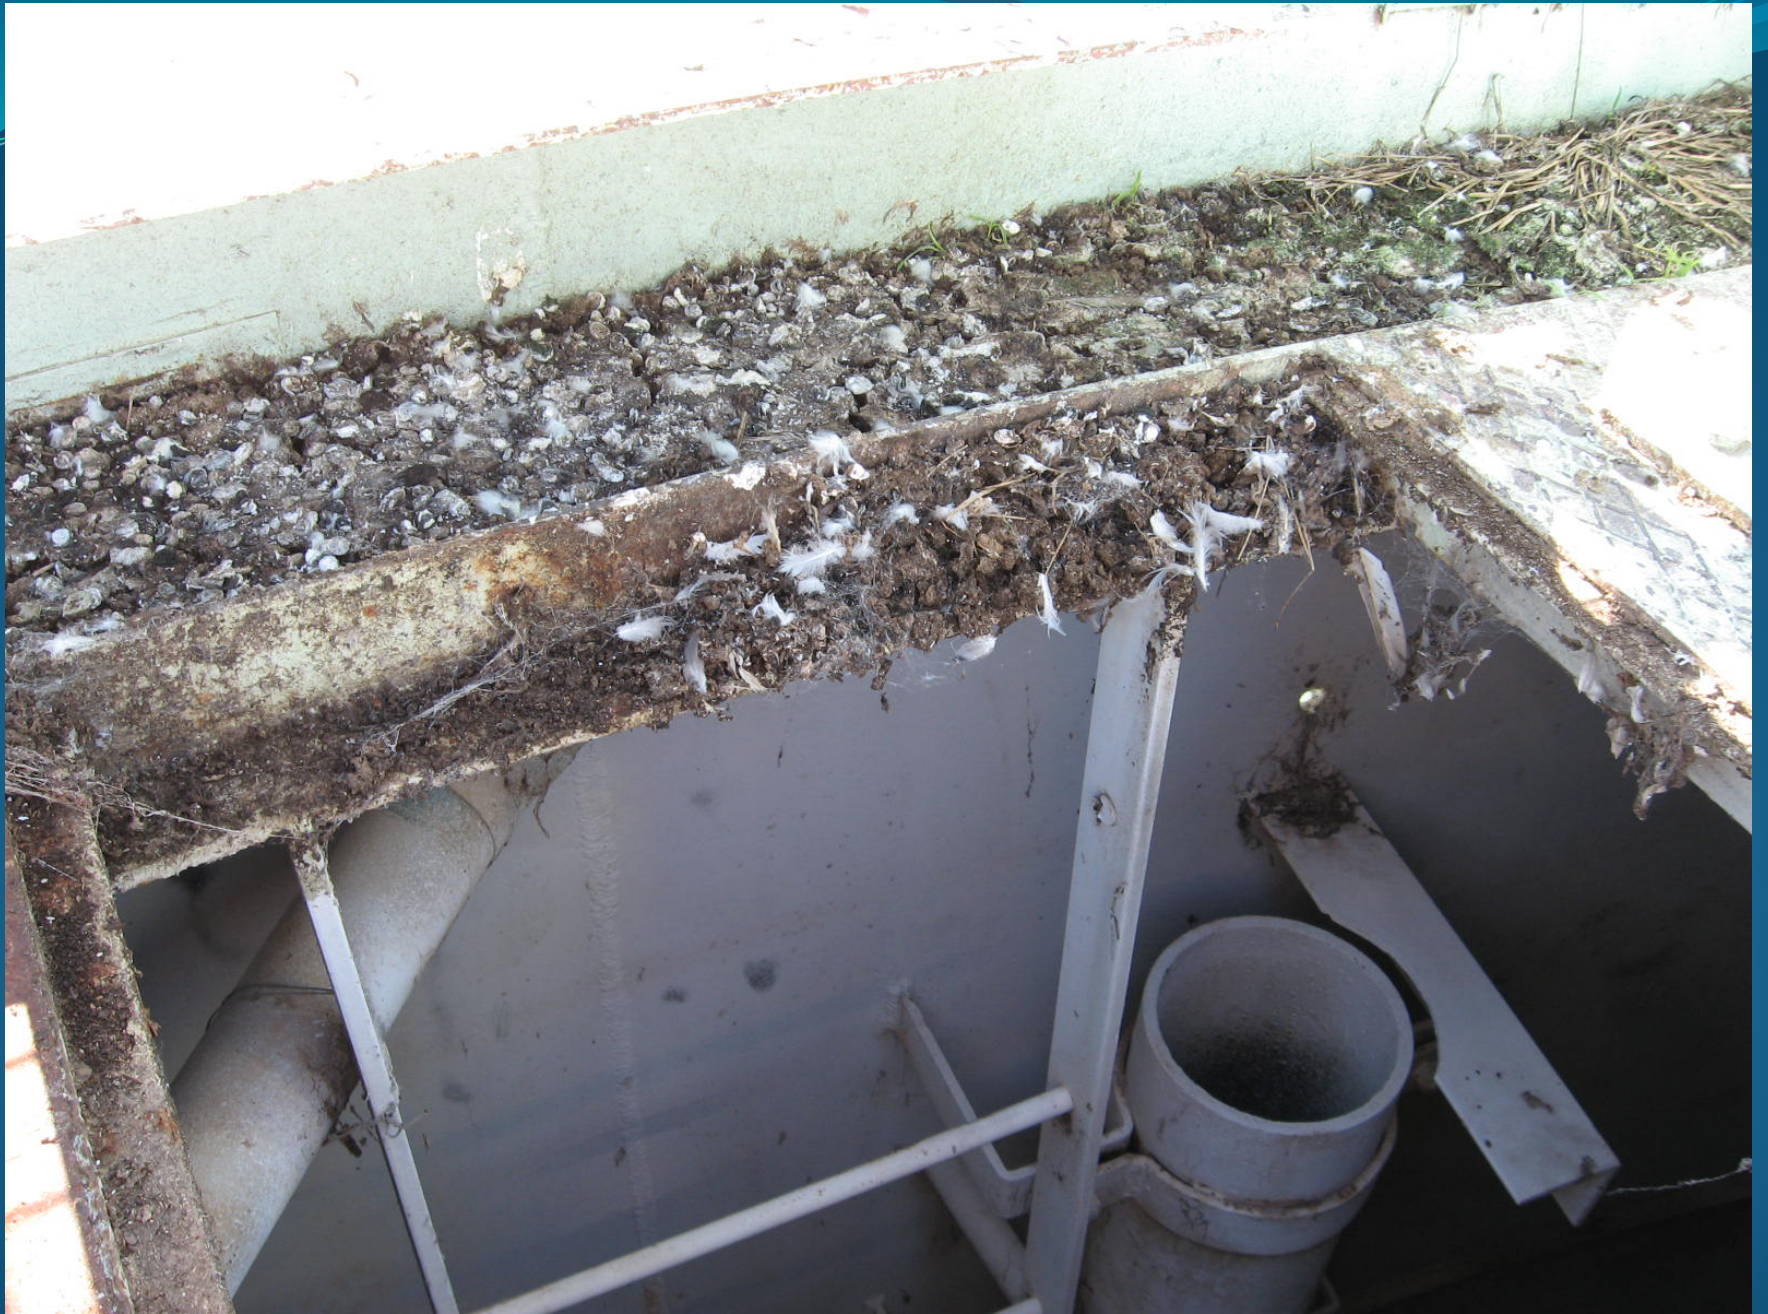
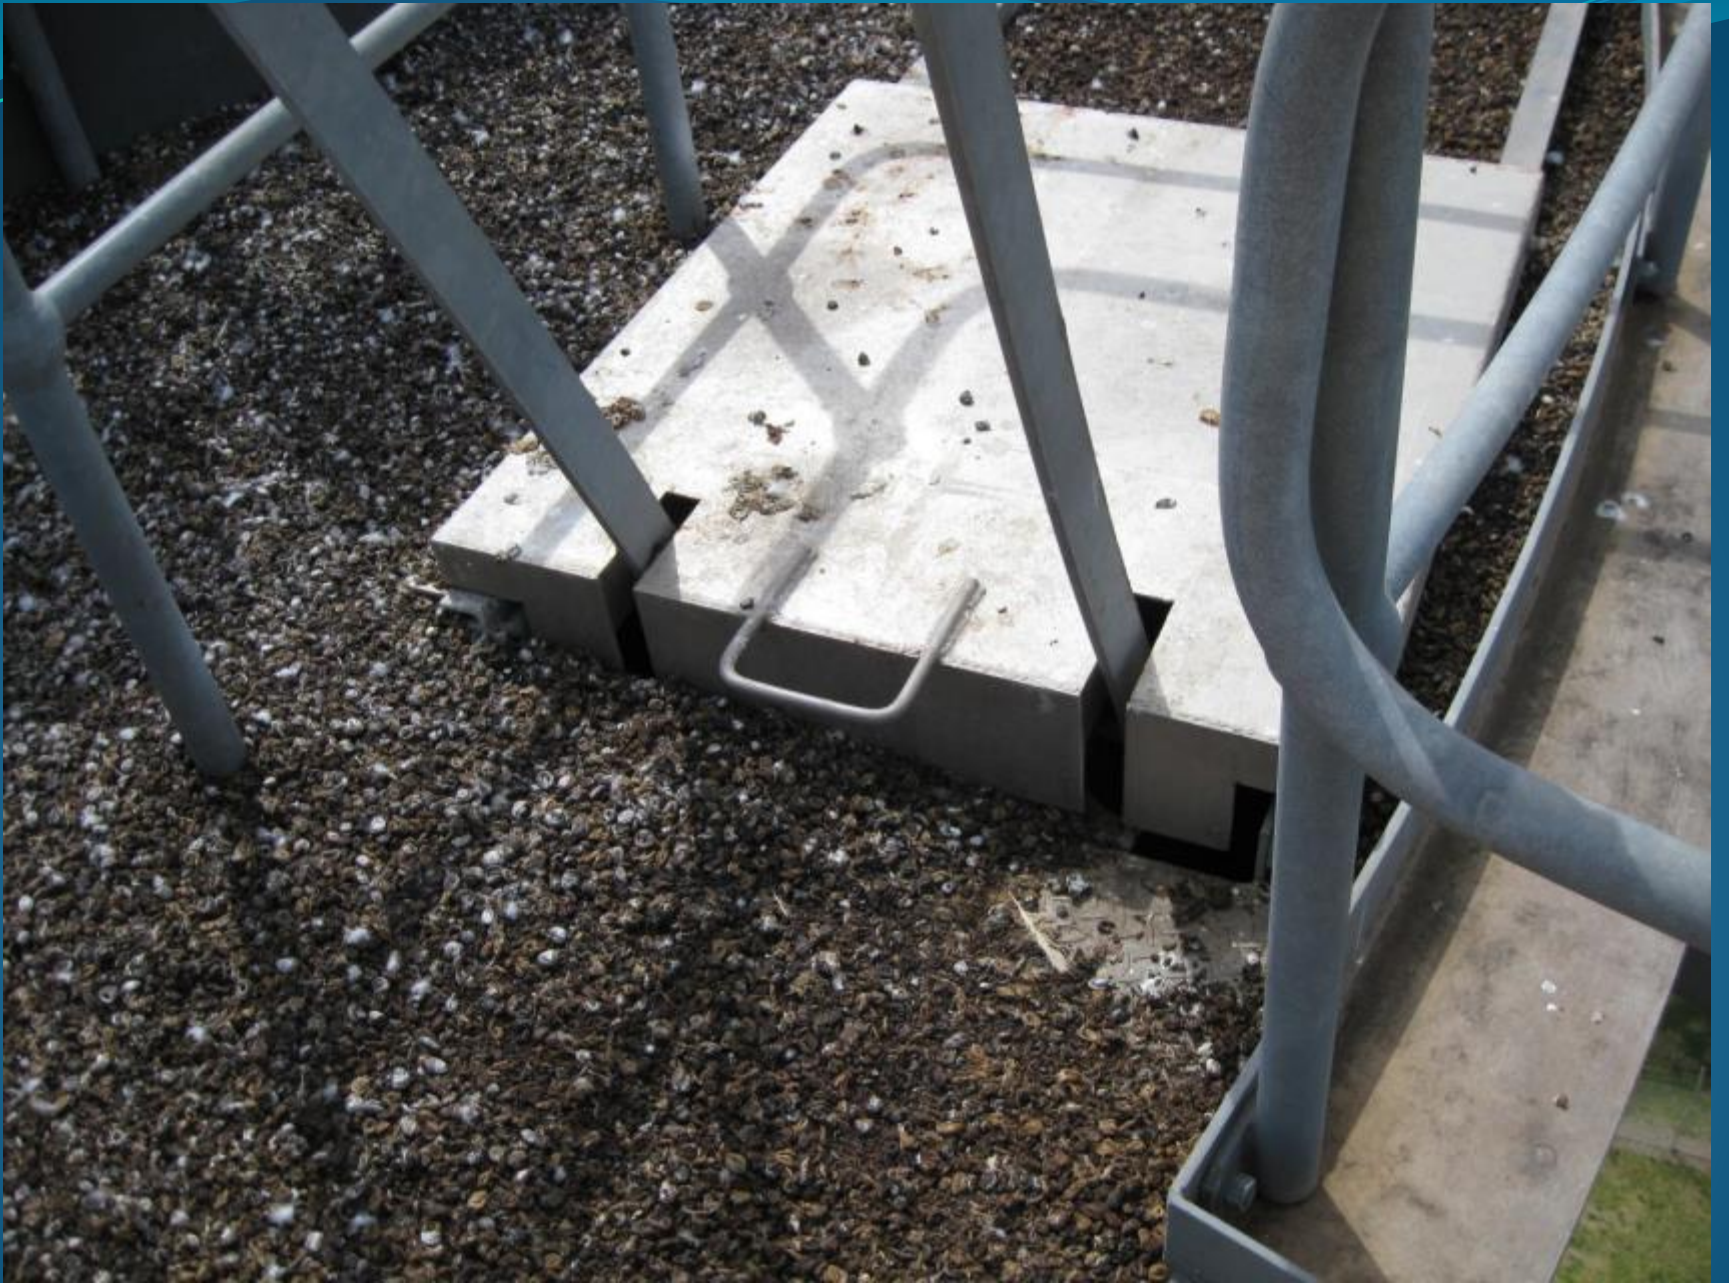
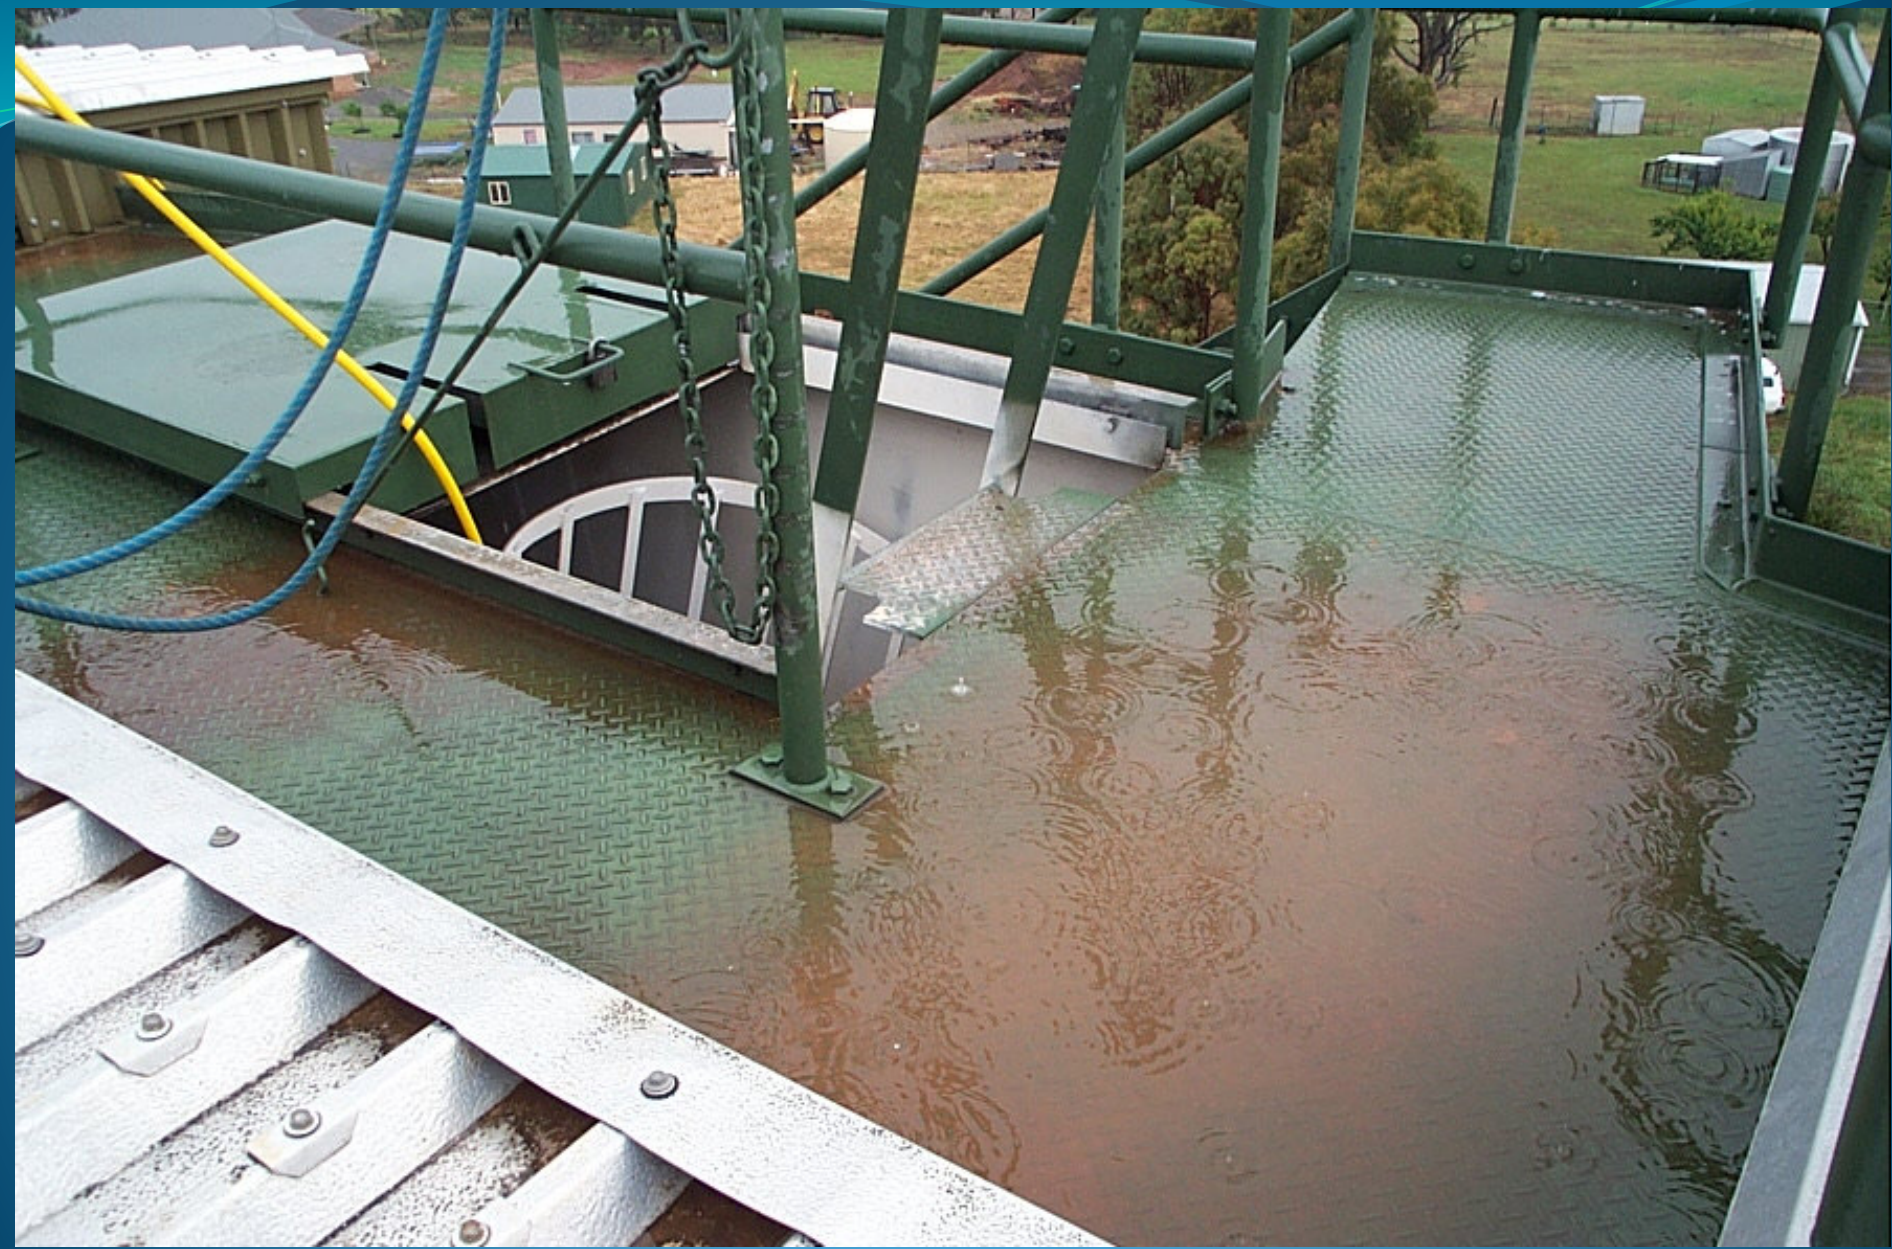
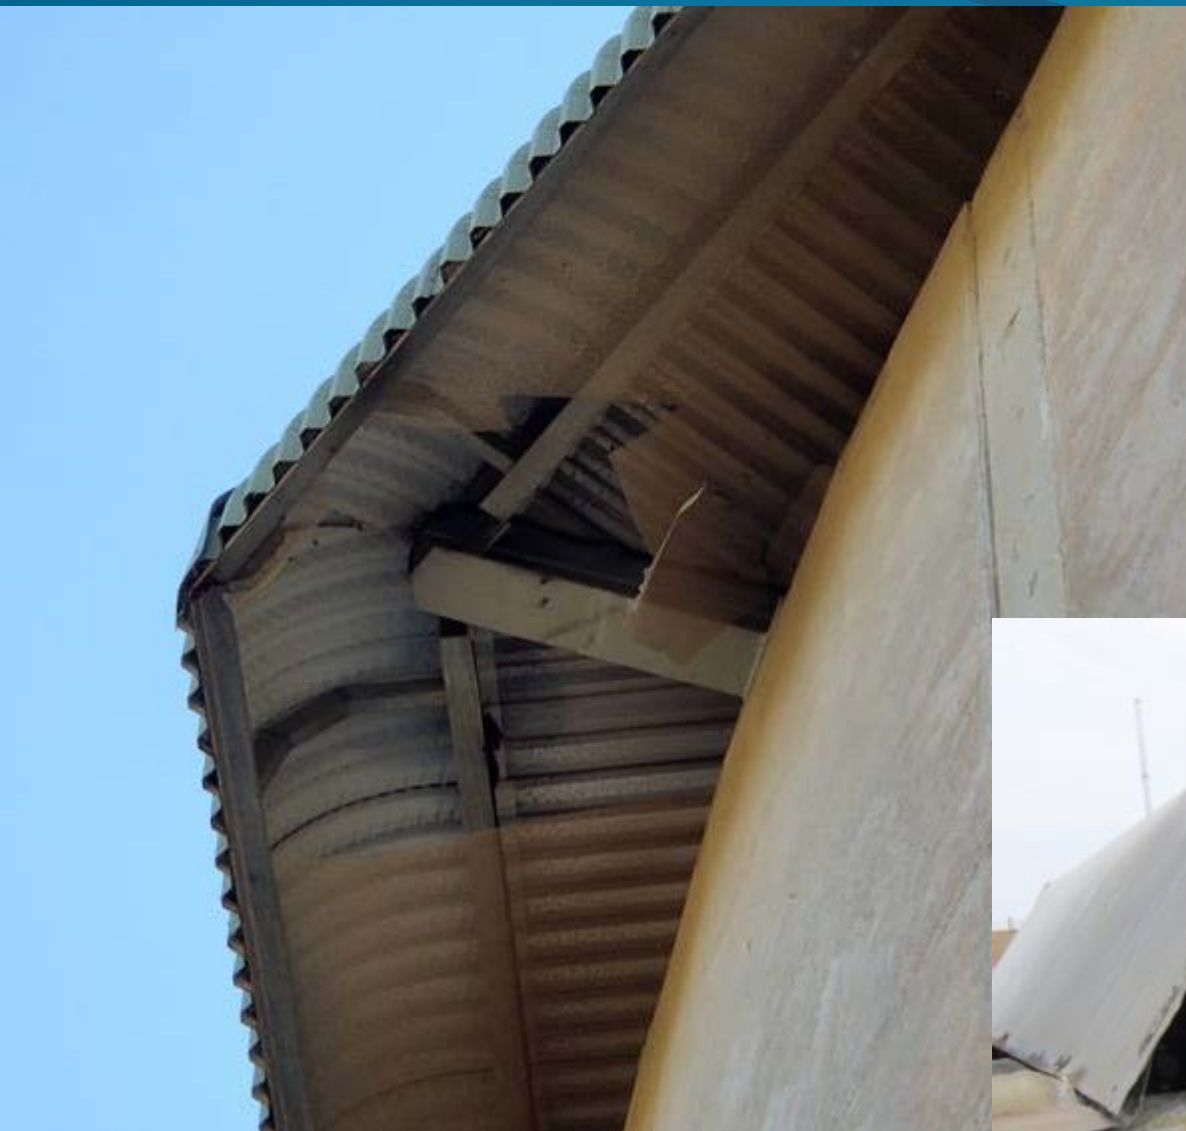
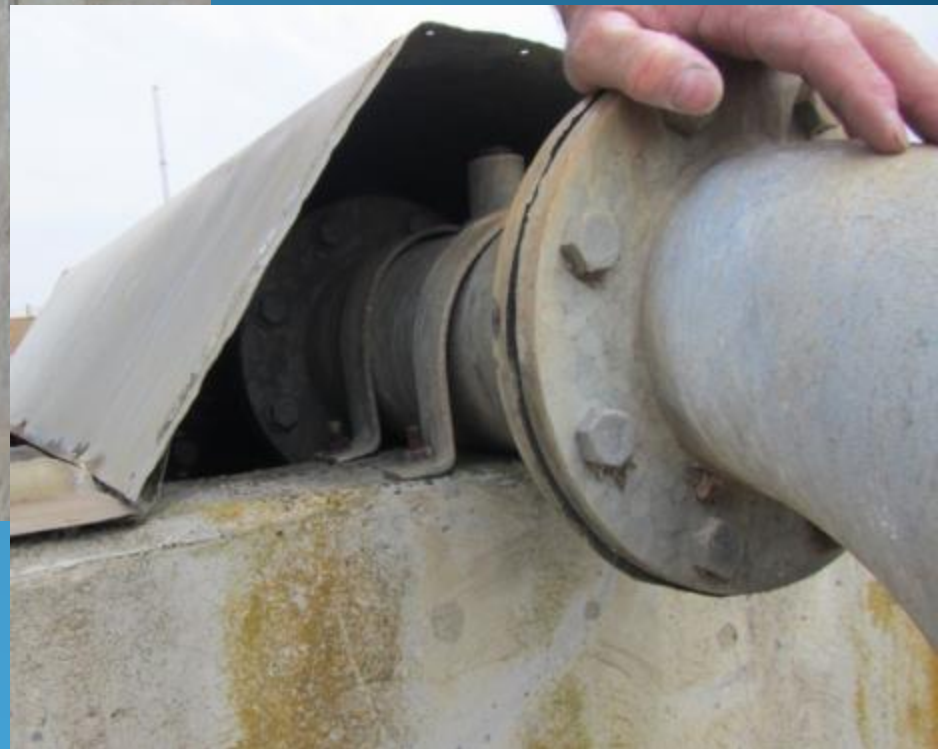
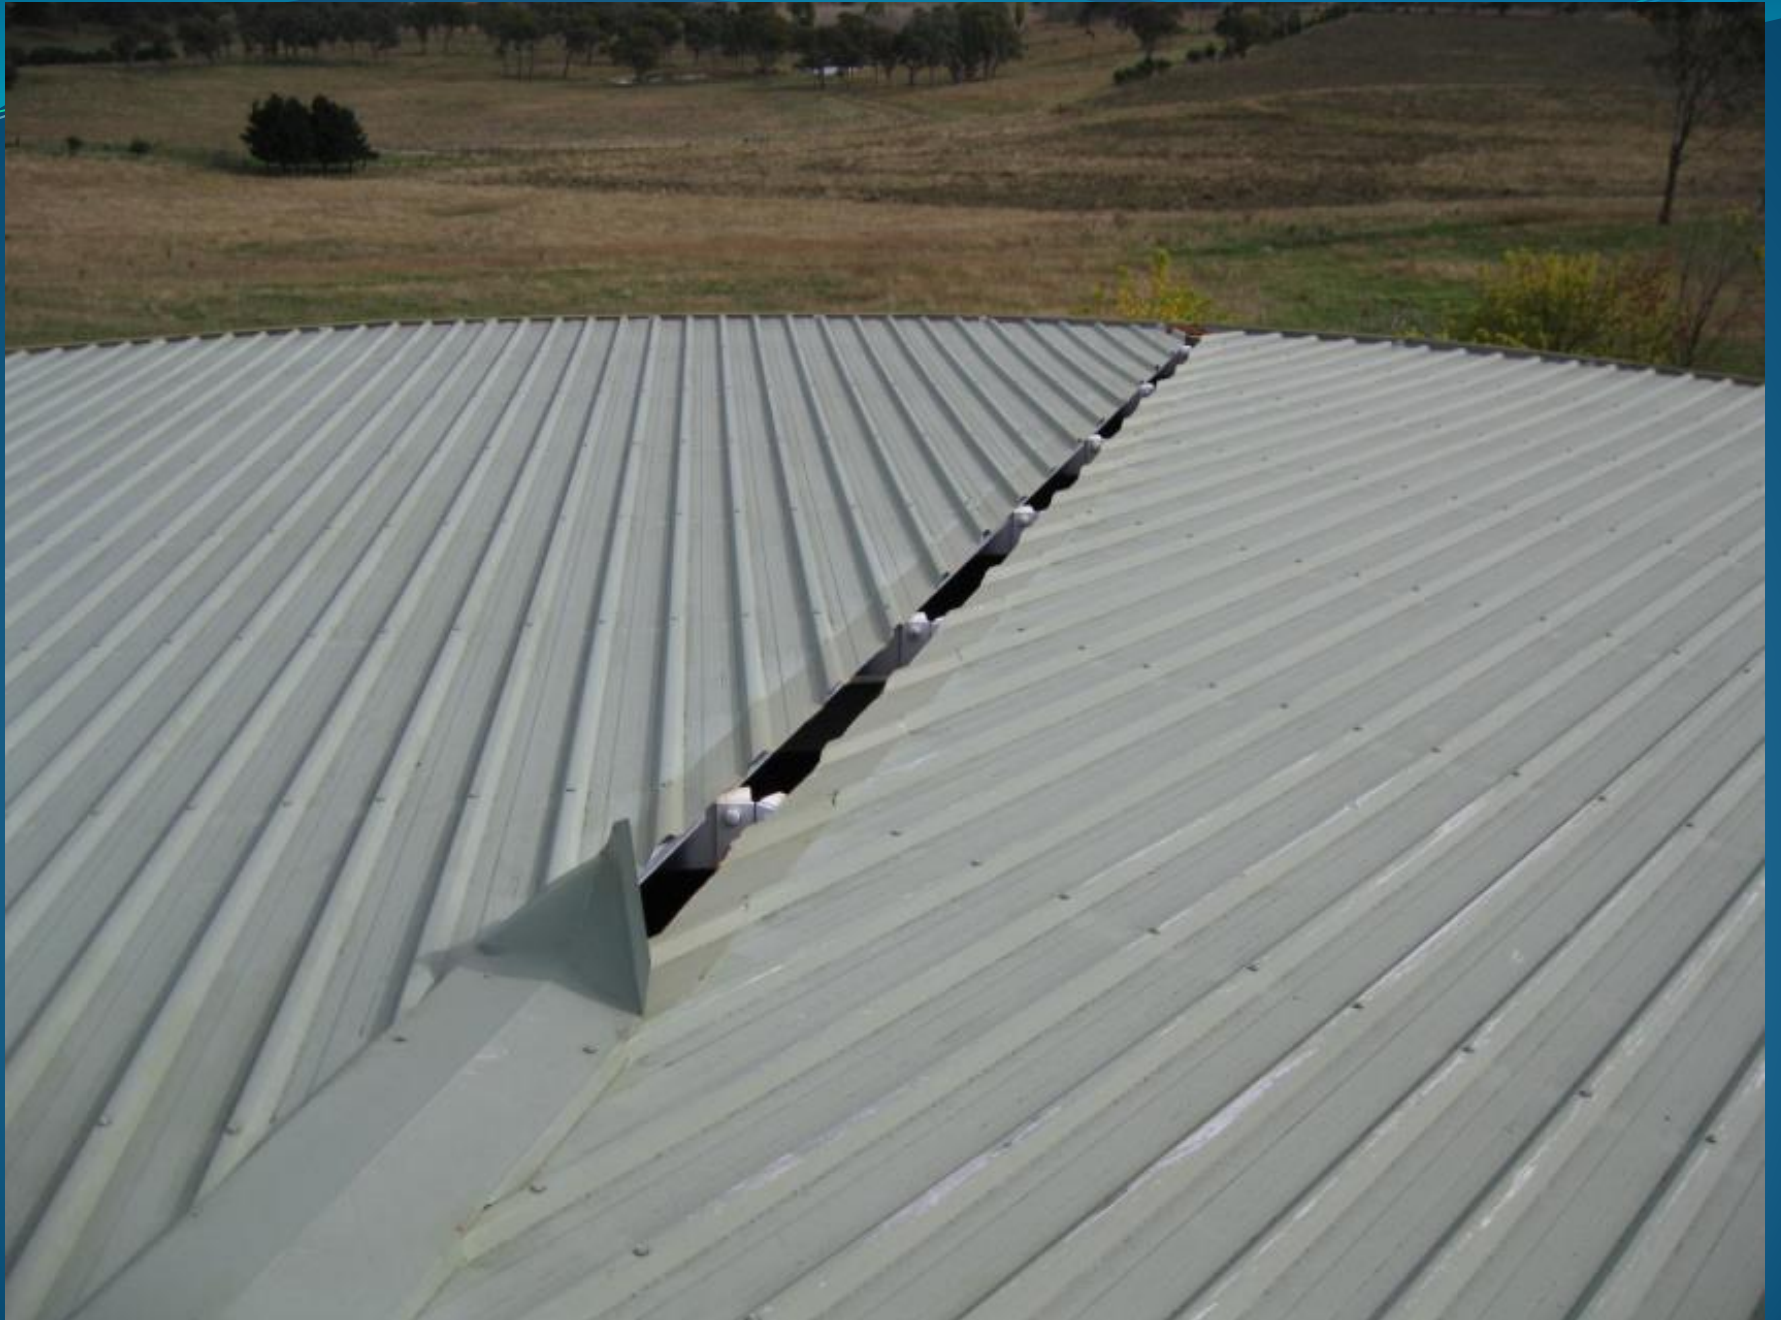
# Obvious contamination..

Faecal material from

- Bird & animal

Dirt and debris

- Any dust, leaf litter & 'dead' bits

Drainage from roof & platform area

Other materials that consume chlorine

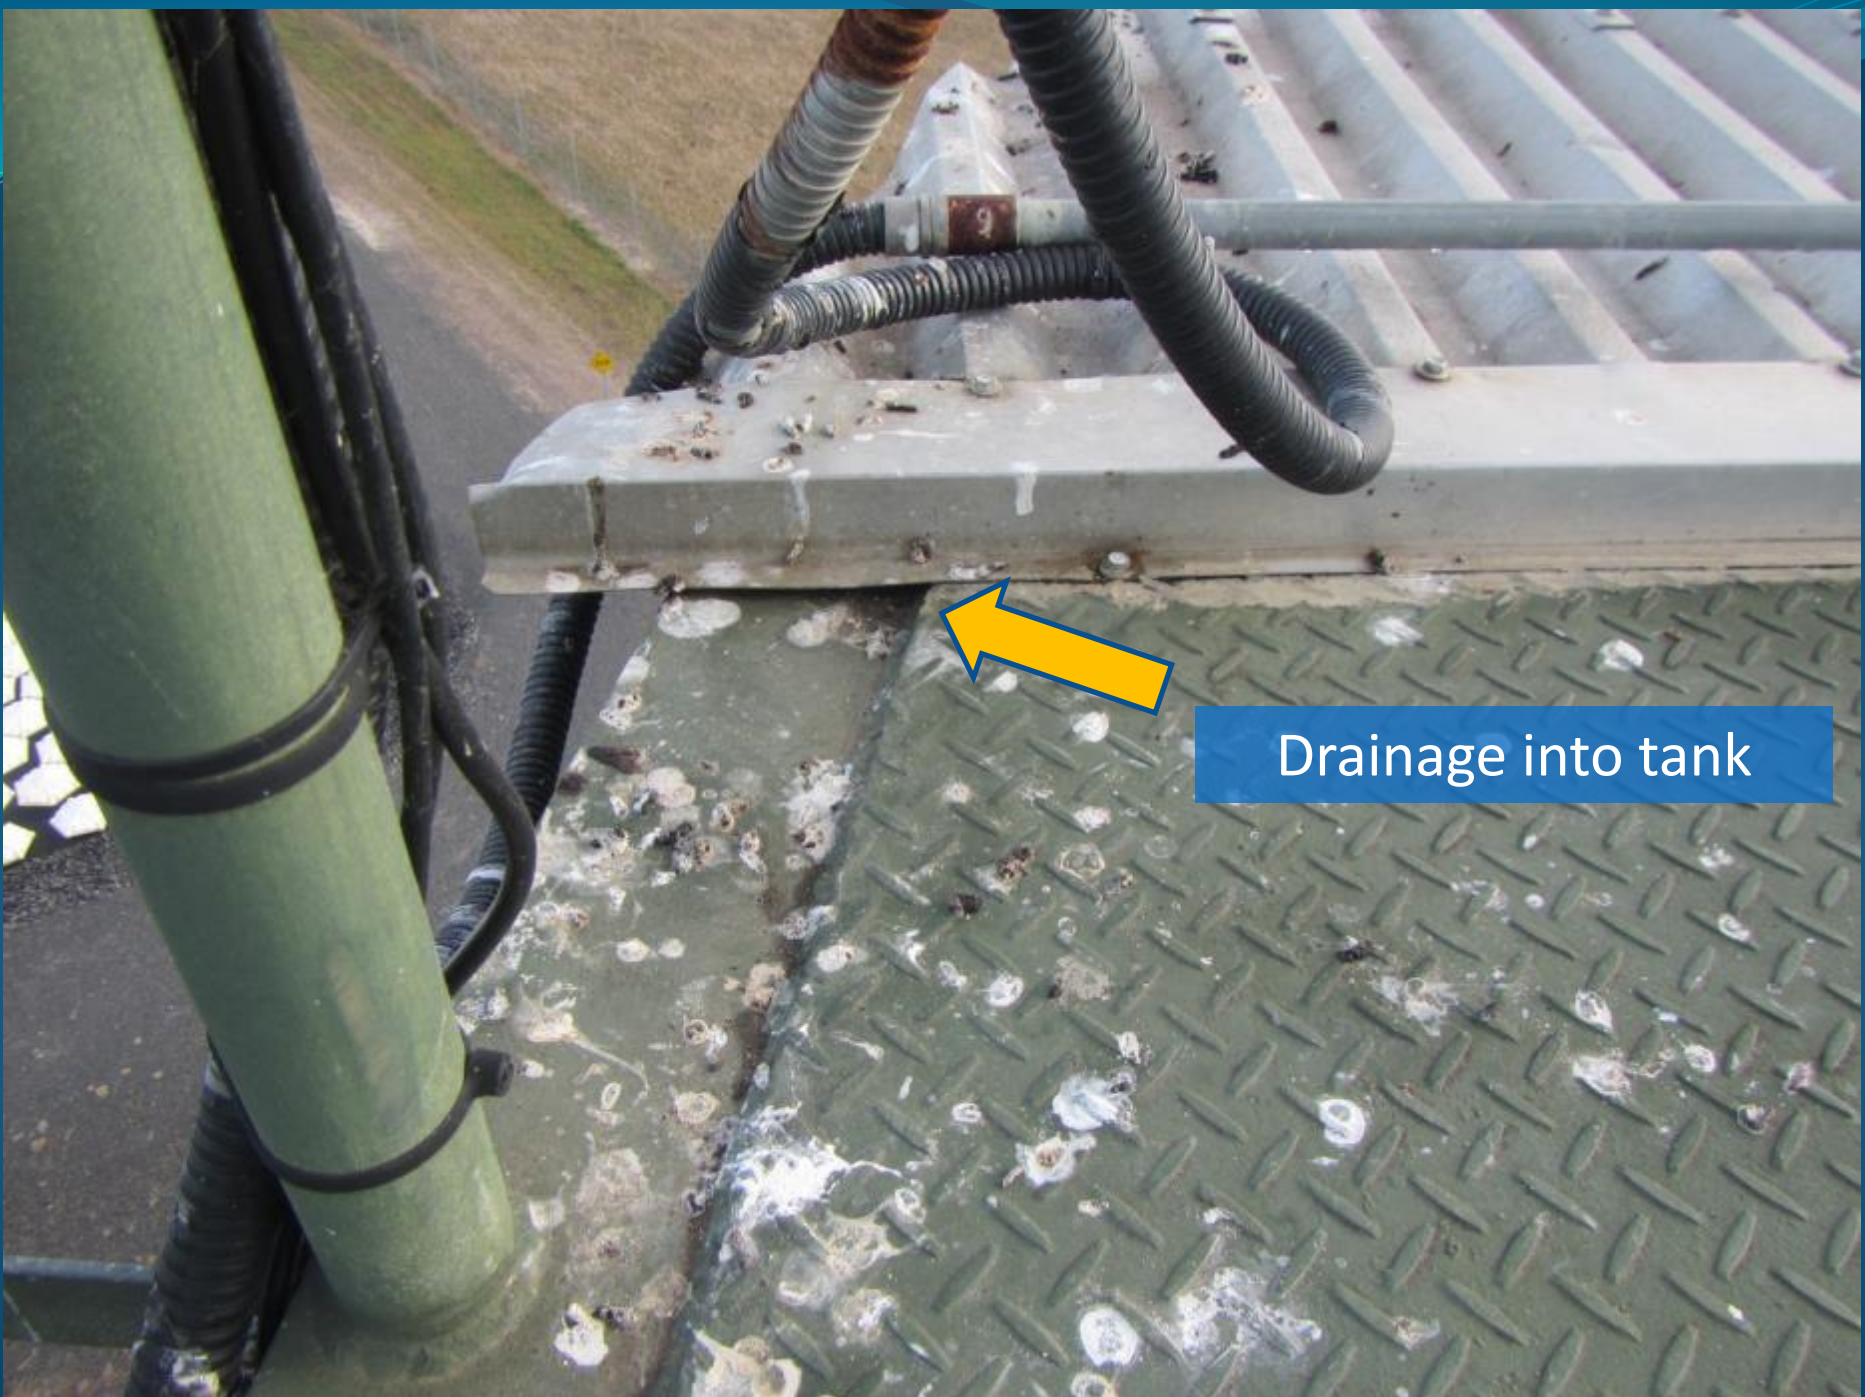
Drainage into tank

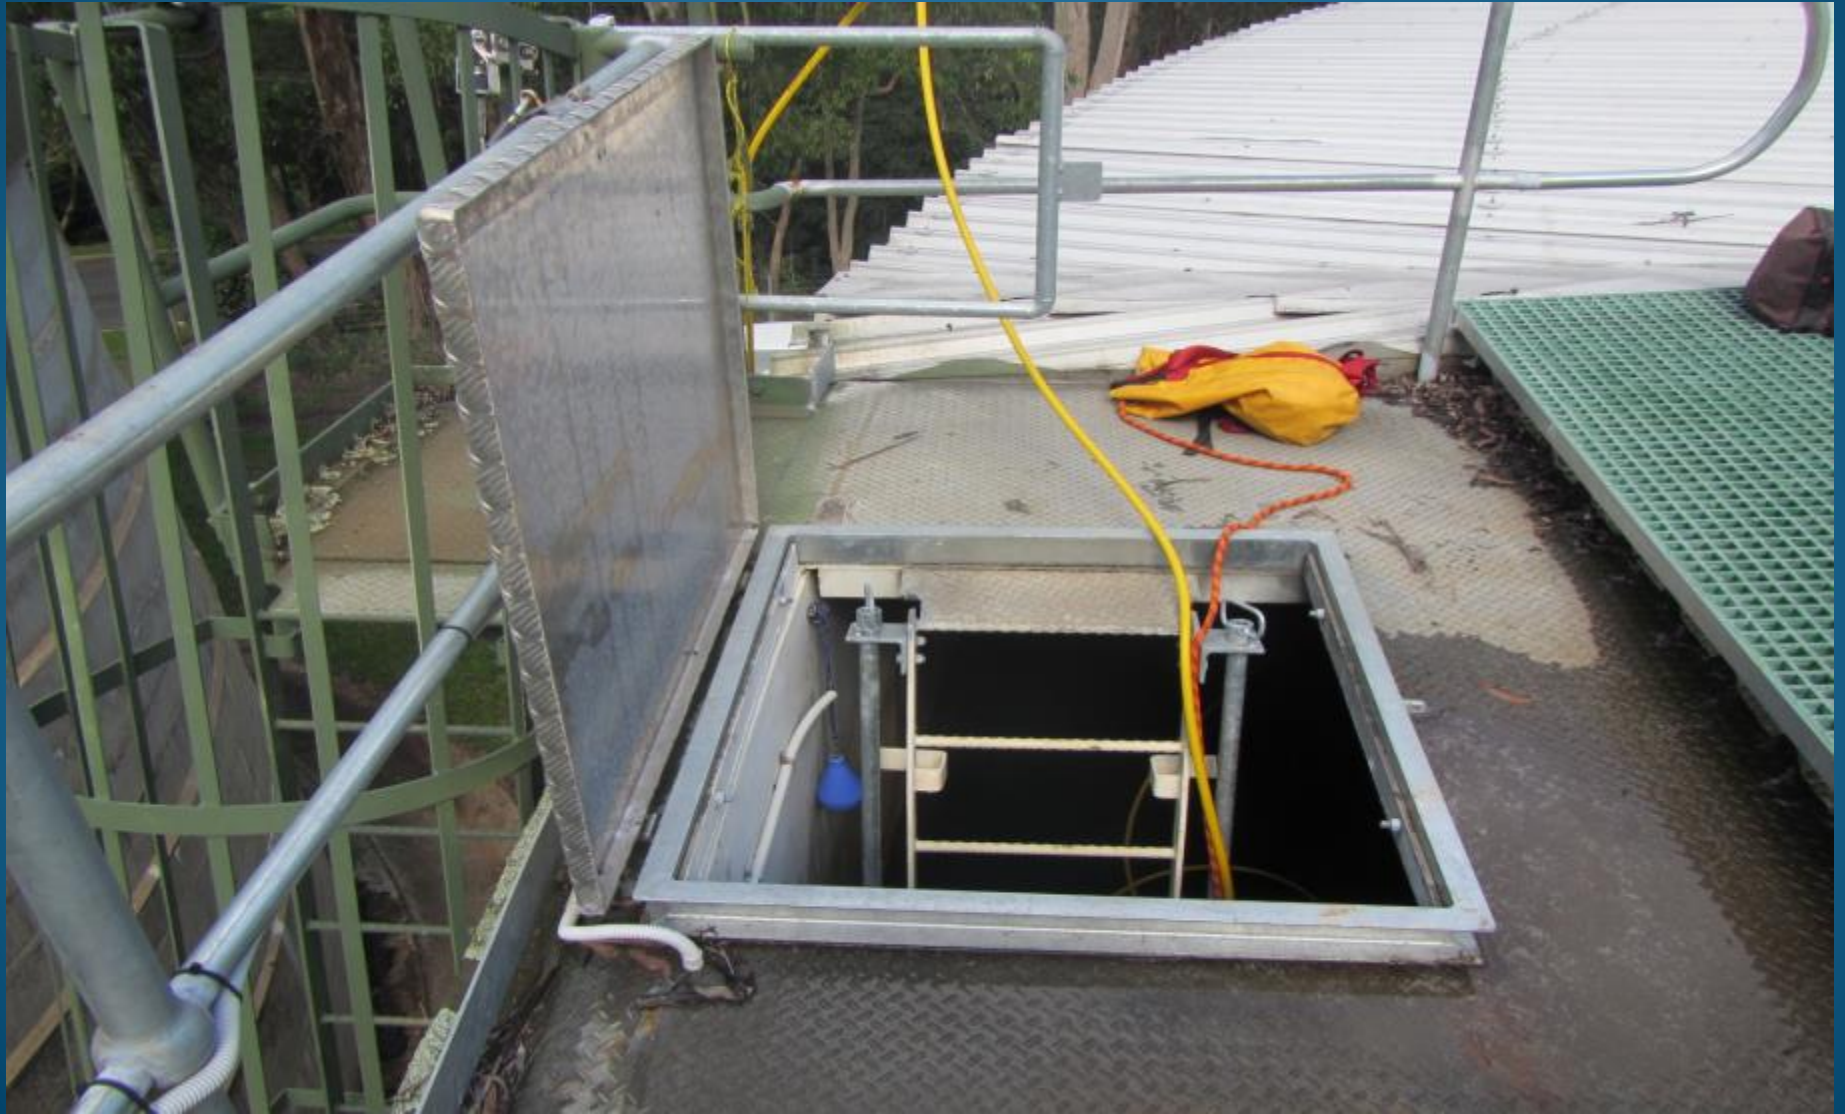
# Entry hatch re-design

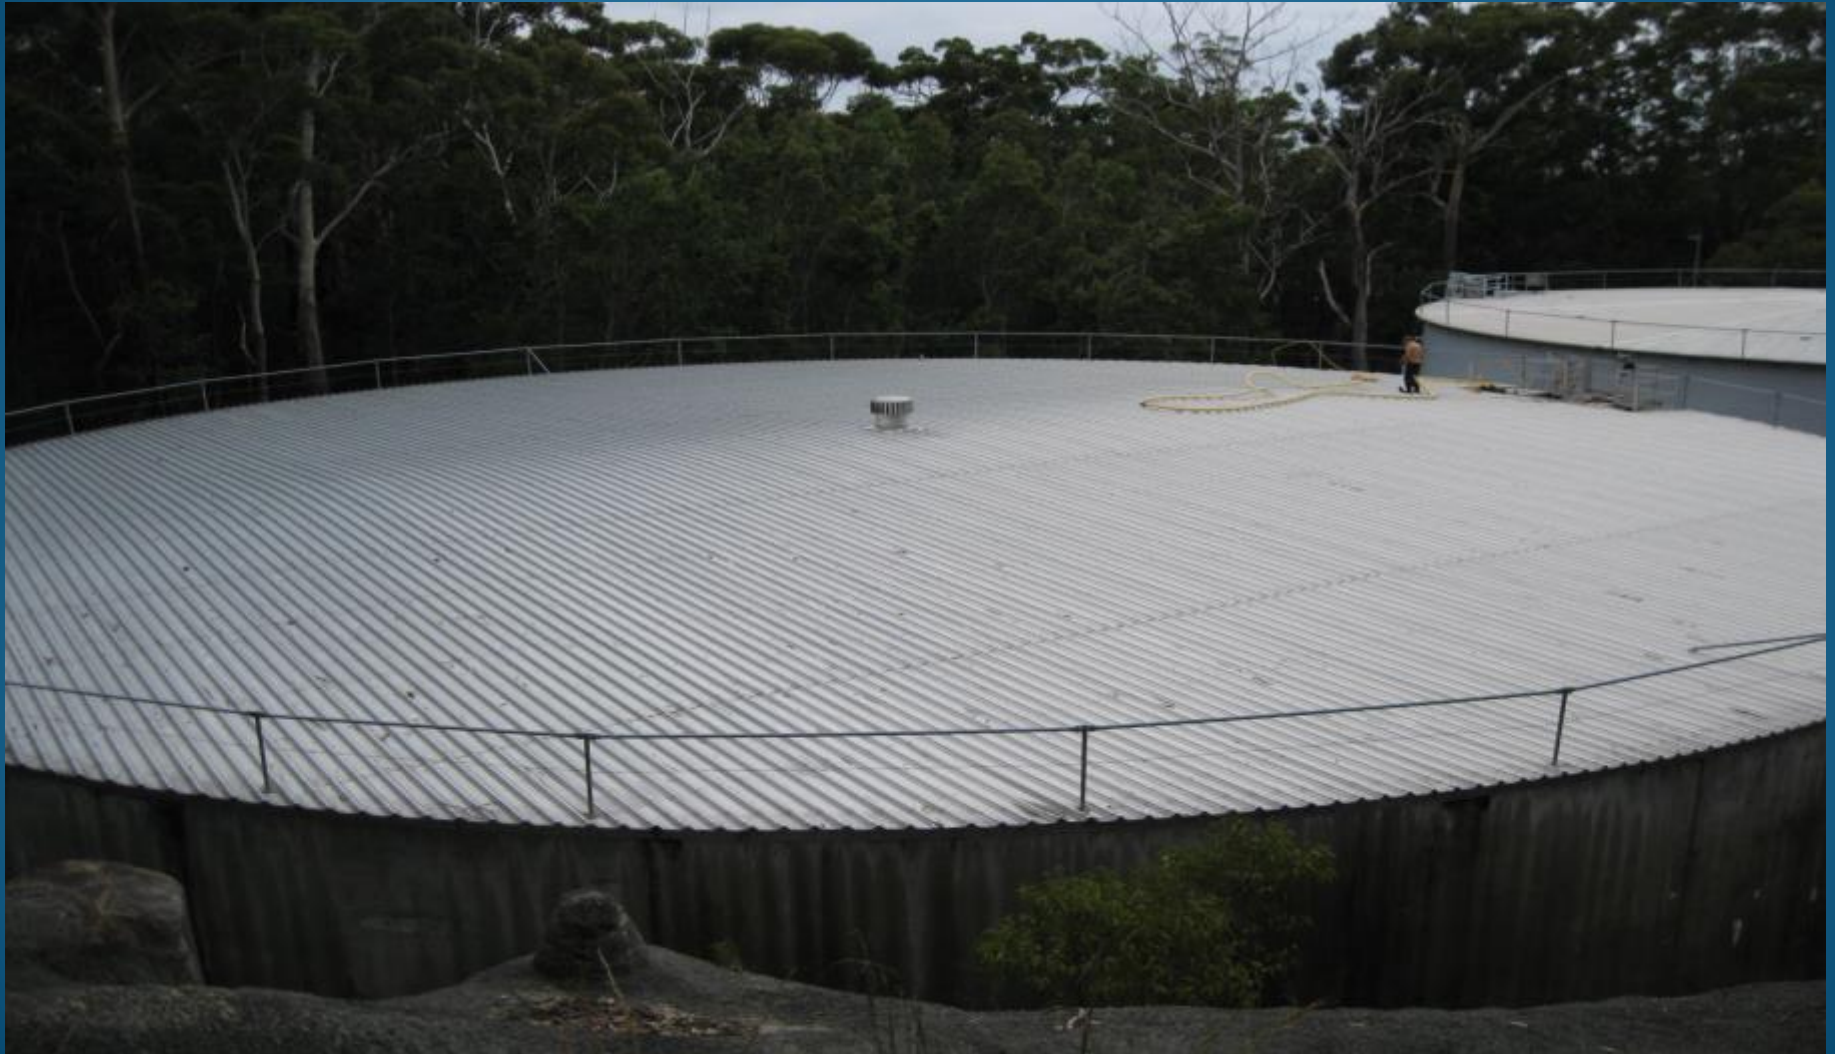
# Roof design good - no flashings, simple and effective
