# Reservoir Awareness and Responsibilities

Jillian Busch and Dave Barry  
Aqualift Project Delivery Pty Ltd  
2014

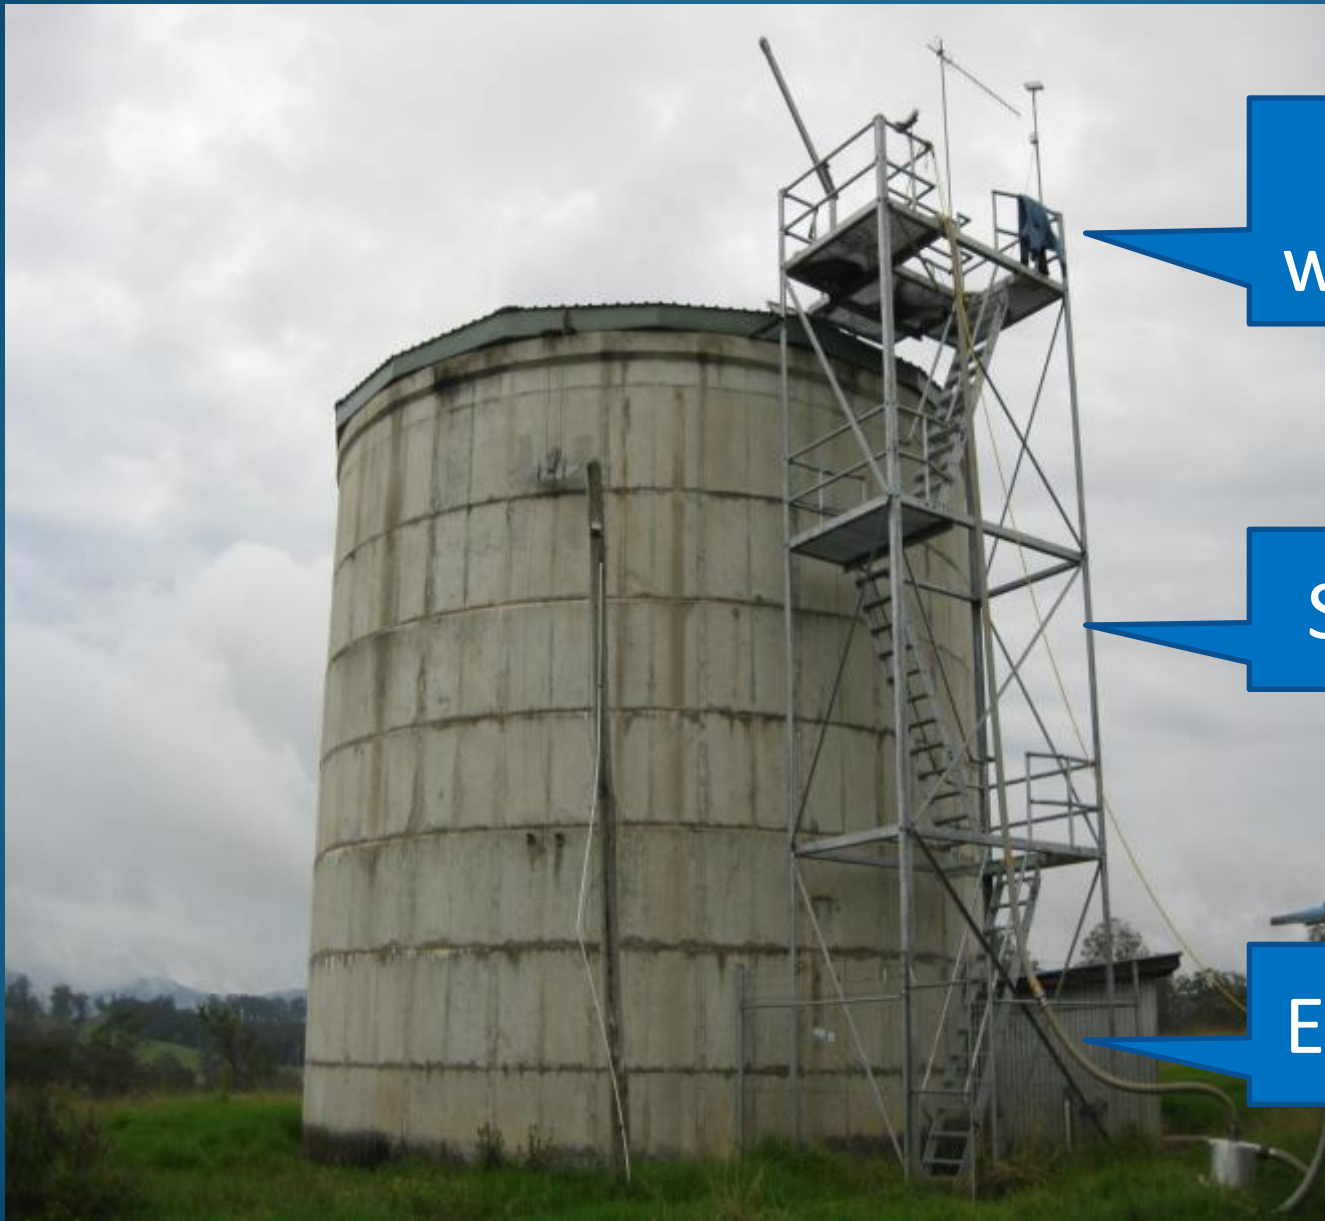
# Security & Access improved

Additional  
working space

Safe to climb

Easy to secure
