RESERVOIR
MAINTENANCE
SPECIALISTS

TYPE 2 RENOVATION

AQUALIFT BUCKET OF WATER TEST

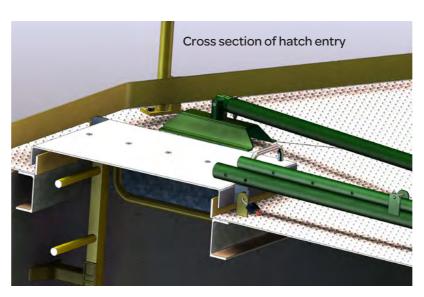
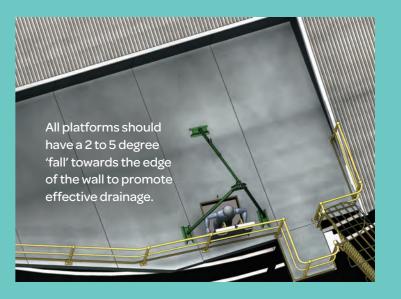
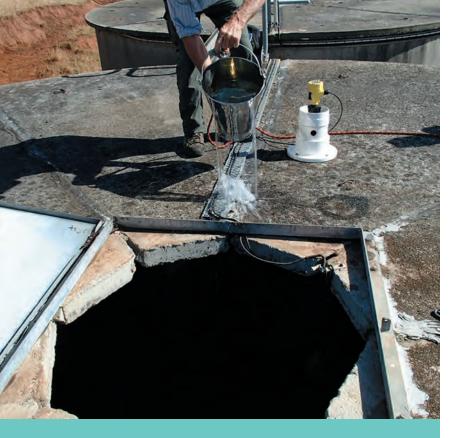
Platforms that 'cut into' the reservoir roof have all the safety and drainage features of Type 1 platform renovations.

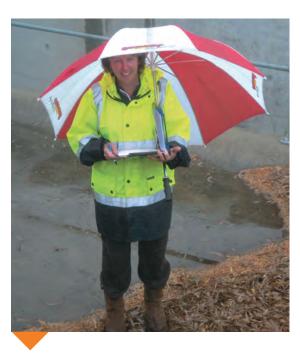
The first method is using a clean bucket and rope to obtain water from the tank and then pour it around any areas that should be sealed, such as platform edges, hatch frames and any fixtures set onto the roof area. And then look (and listen) inside the tank to see or hear any water ingress.

Several methods of verifying how well tanks are sealed against contamination entry are now available to clients, contractors and asset inspectors.

Contamination entry into drinking water is not always obvious to the untrained eye and it is important to identify issues taking place before a 'boiled water alert' is issued.

While older tank hatches, platforms and roof structures will always have to be suspected, most new constructions are assumed to be OK...because they are new! Many clients have been surprised... and disappointed to see water draining past supposedly 'newly sealed areas'.
